Site:	-				
Job No:	130128A				
Action Note No:	XXX 13-006				
Panel ID No.:	EPS 0027	Fault temperature, °C:	63.8		
Machine Tag No.:	P01001	Reference temperature, °C:	45.3		
Description:	Tower 2 Propeller Pump		Ambient temperature, °C:	23.0	
Date Raised:	16/09/13		Load, Amps:	80	
Report By:	Andy Mellor		Full Load Current, Amps:	85	
Contact No:	07913-493151		Rise over Reference at FLC, °C:	20.6	
E-Mail:	andy.mellor@pmar.co.uk		Max temp at FLC, 25°C Ambient, °C:	70.5	
Asset Health	 Serious 	 IR Visual	 Serious OK	 UE Other	 NS NS
Report:	<p>Significant temperature rise on brown phase between inverter and contactor. Hottest temperature is at connection to contactor but connection to inverter also shows temperature rise (see over for additional images). Phase currents compared and found to be 79 A (Brown) & 81 A (Black & Grey). The maximum projected temperature is at the limit for PVC insulation. Exact cause uncertain as thermal profile does not match expected profile from poor connection.</p>

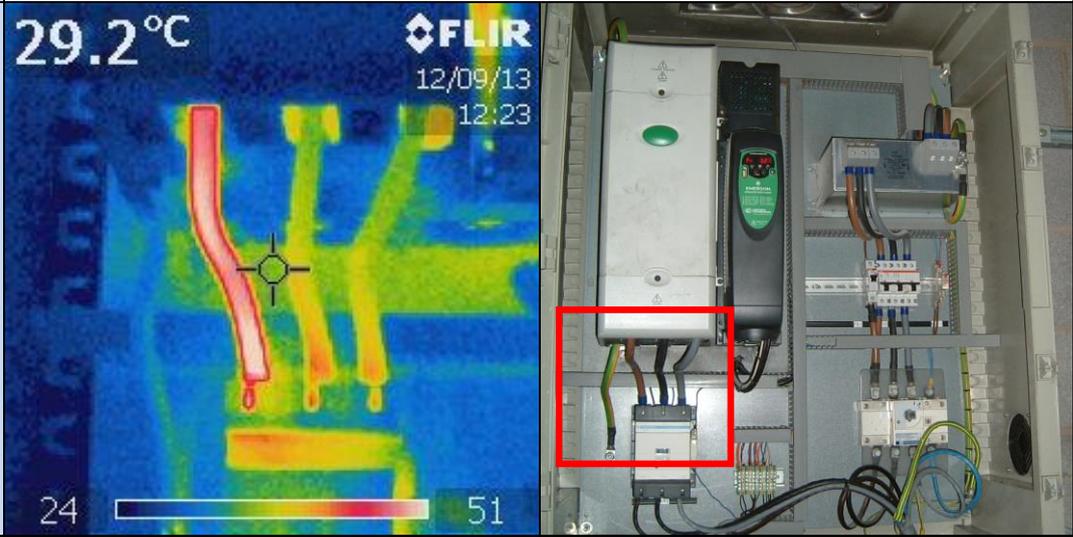
<p>53.1°C FLIR 12/09/13 12:24</p> <p>25 52</p>	<p>29.9°C FLIR 12/09/13 12:24</p> <p>25 43</p>	<p>31.4°C FLIR 12/09/13 12:24</p> <p>25 38</p>
<p>Connection to Inverter, Brown phase</p>	<p>Connection to Inverter, Black phase</p>	<p>Connection to Inverter, Grey phase</p>
	<p>63.8°C FLIR 12/09/13 12:24</p> <p>26 63</p>	
<p>Close-up of contactor and bottom of inverter</p>	<p>Connection to top of contactor, Brown phase (left) and Black phase (right)</p>	
<p>43.9°C FLIR 12/09/13 12:23</p> <p>26 46</p>		
<p>Connections to bottom of contactor, Brown phase is at left</p>	<p>Close-up of contactor</p>

Recommendations:	<p>In the first instance, check at both inverter and contactor for: 1) loose connection, 2) improperly made crimped connections. Suggest replacement cable is made up and installed in order to minimise pump downtime.</p>				
Feedback:	<p>Please provide feedback following remedial action:</p>
