# A Qualitative Infrared Thermographic Survey of Electrical System Components

*The Widget Building - Widgetville Michigan*

3-11-2009

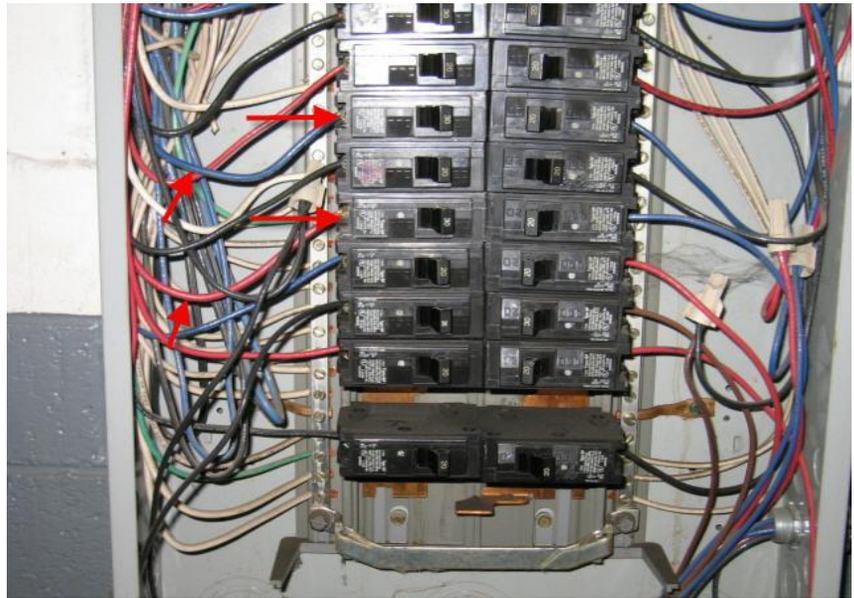
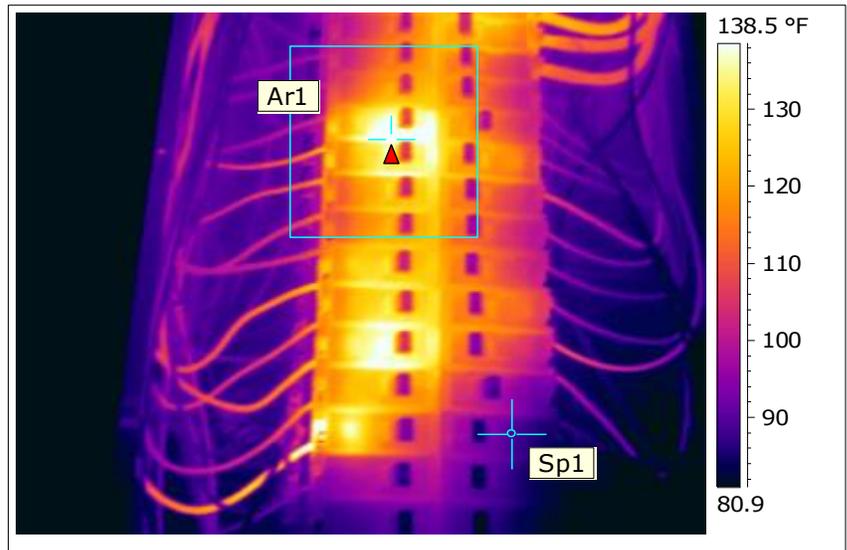
<b>REPORT #: 1</b>	
<b>CLIENT</b>	Pinnacle Widgets Inc
<b>BUILDING</b>	The Widget Building
<b>AREA 1</b>	Plant 4
<b>AREA 2</b>	Shipping Dept
<b>EQPT NAME</b>	P4-D Lighting Panel
<b>Image Date</b>	3/11/2009
<b>Image Time</b>	5:05:38 PM
<b>Image File Name</b>	IR_1.jpg

<b>Reference Temperature</b>	
Sp1.Temperature 100.3 °F	
Ar1.Max Temperature 167.4 °F	
Temperature Rise: 67 °F	
<b>Fault Rating Serious</b>	
<b>AMPERAGES:</b>	
Phase A	Amp Phase A: NA
Phase B	Amp Phase B: NA
Phase C	Amp Phase C: NA

**Possible Equipment Damage -** The thermal image is indicative of potential internal damage or a defective breaker. We recommend satisfactory equipment operation with subsequent repairs or replacements as needed.

**Overload conditions may also be issues which are to be investigated.**

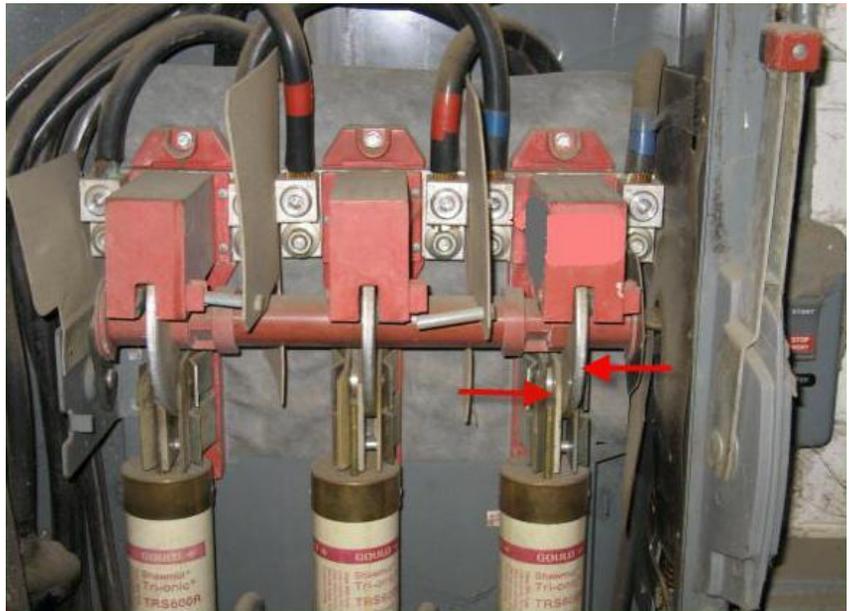
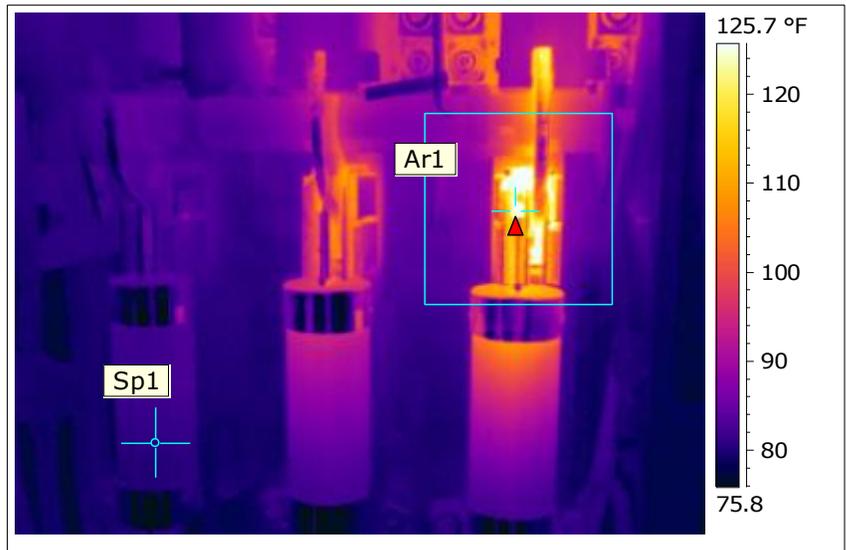
<b>REPORT #: 2</b>	
<b>CLIENT</b>	Pinnacle Widgets Inc
<b>BUILDING</b>	The Widget Building
<b>AREA 1</b>	Plant 4
<b>AREA 2</b>	Boiler #5
<b>EQPT NAME</b>	P4 FDISC Feedwater Pump
<b>Image Date</b>	3/11/2009
<b>Image Time</b>	5:34:29 PM
<b>Image File Name</b>	IR_2.jpg

<b>Reference Temperature</b>	
Sp1.Temperature 90.8 °F	
Ar1.Max Temperature 152.4 °F	
Temperature Rise: 62 °F	
<b>Fault Rating Serious</b>	
<b>AMPERAGES:</b>	
Phase A	Amp Phase A: NA
Phase B	Amp Phase B: NA
Phase C	Amp Phase C: NA

**Poor Connections** - The thermal image finding is often indicative of a loose or poor connection. We recommend checking connection integrity with repairs as may be necessary.

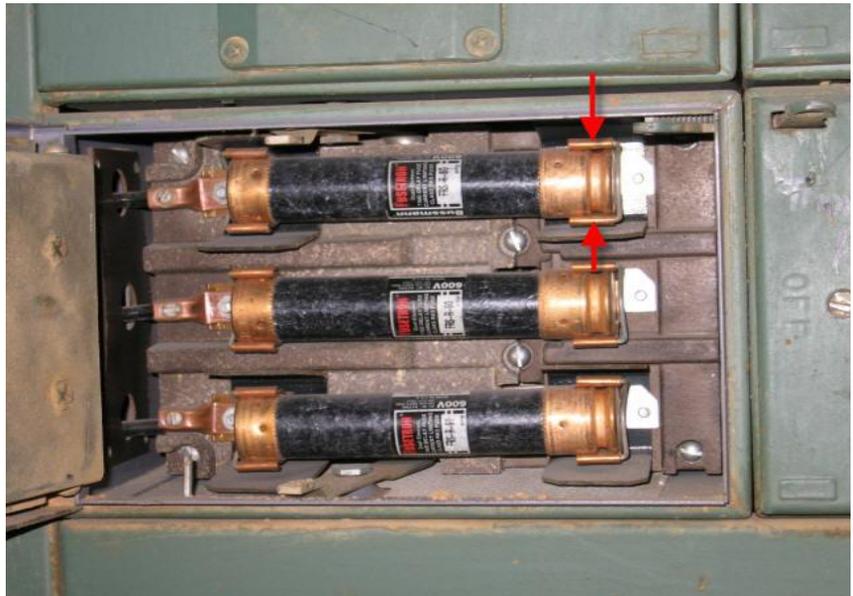
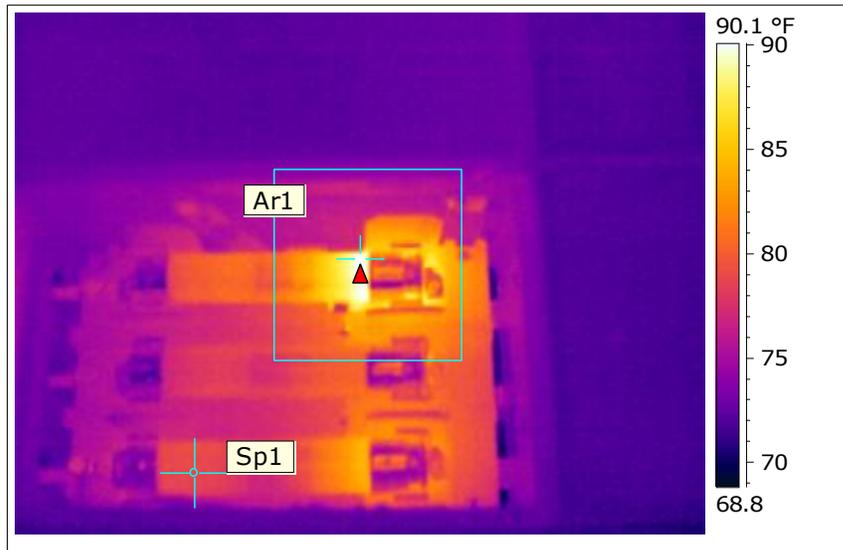
<b>REPORT #: 3</b>	
<b>CLIENT</b>	Pinnacle Widgets Inc
<b>BUILDING</b>	The Widget Building
<b>AREA 1</b>	Plant 5 Computer Room
<b>AREA 2</b>	Main
<b>EQPT NAME</b>	P5-C1 FDISC
<b>Image Date</b>	3/11/2009
<b>Image Time</b>	3:54:32 PM
<b>Image File Name</b>	IR_3.jpg

<b>Reference Temperature</b>	
Sp1.Temperature 88.6 °F	
Ar1.Max Temperature 102.5 °F	
Temperature Rise: 14 °F	
<b>Fault Rating Minor</b>	
<b>AMPERAGES:</b>	
Phase A	Amp Phase A: NA
Phase B	Amp Phase B: NA
Phase C	Amp Phase C: NA

**Poor Connections** - The thermal image finding is often indicative of a loose or poor connection. We recommend checking connection integrity with repairs as may be necessary.

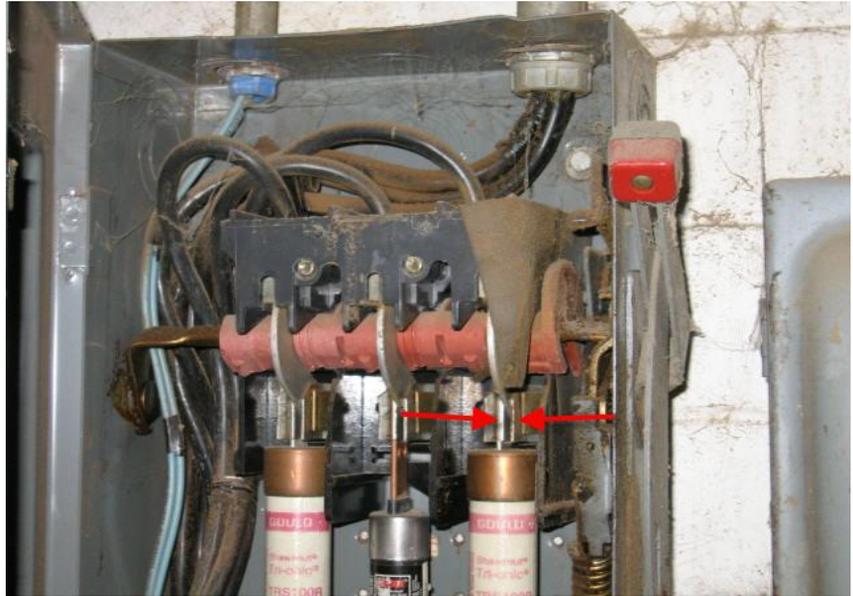
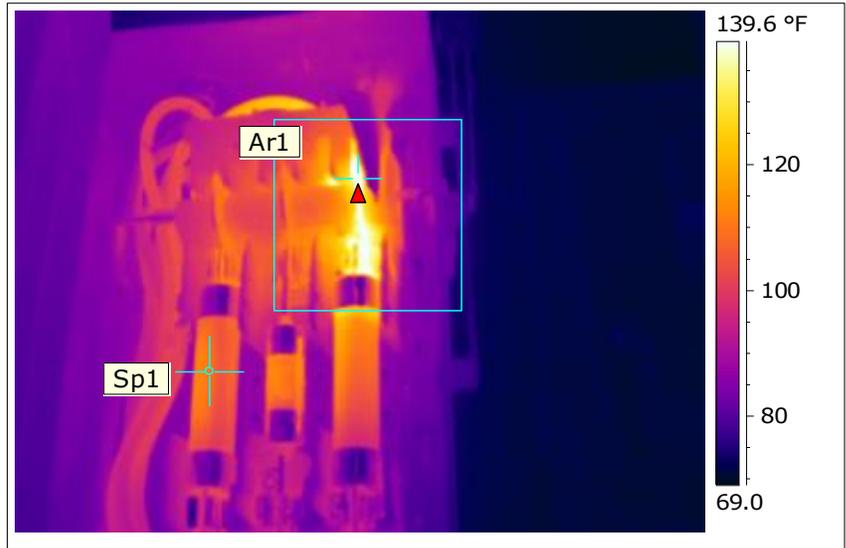
<b>REPORT #:</b> 4	
<b>CLIENT</b>	Pinnacle Widgets Inc
<b>BUILDING</b>	The Widget Building
<b>AREA 1</b>	Chip Core Bldg
<b>AREA 2</b>	Main
<b>EQPT NAME</b>	P49A FDISC
<b>Image Date</b>	3/11/2009
<b>Image Time</b>	5:38:26 PM
<b>Image File Name</b>	IR_4.jpg

<b>Reference Temperature</b>	
Sp1.Temperature	123.5 °F
Ar1.Max Temperature	171.7 °F
Temperature Rise:	48 °F
<b>Fault Rating Alert</b>	
<b>AMPERAGES:</b>	
Phase A	Amp Phase A: NA
Phase B	Amp Phase B: NA
Phase C	Amp Phase C: NA

**Poor Connections** - The thermal image finding is often indicative of a loose or poor connection. We recommend checking connection integrity with repairs as may be necessary.

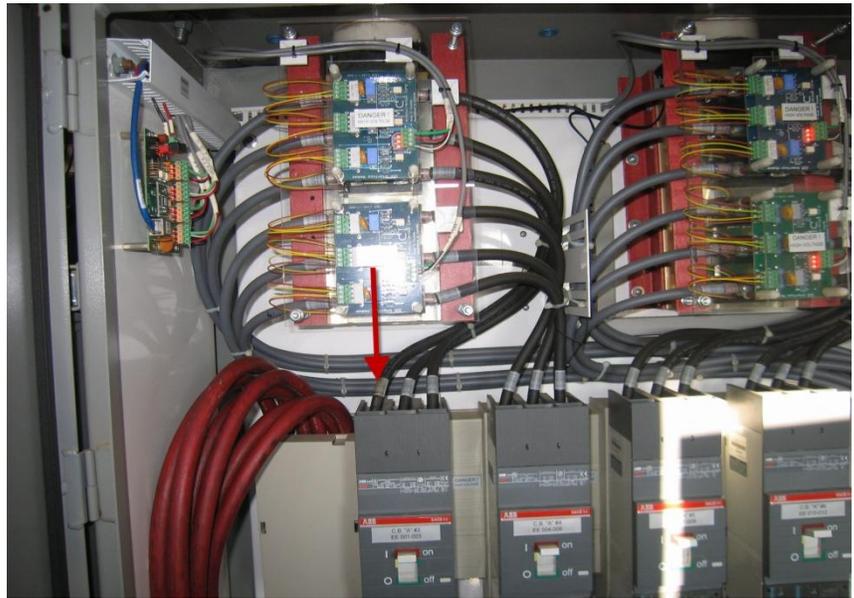
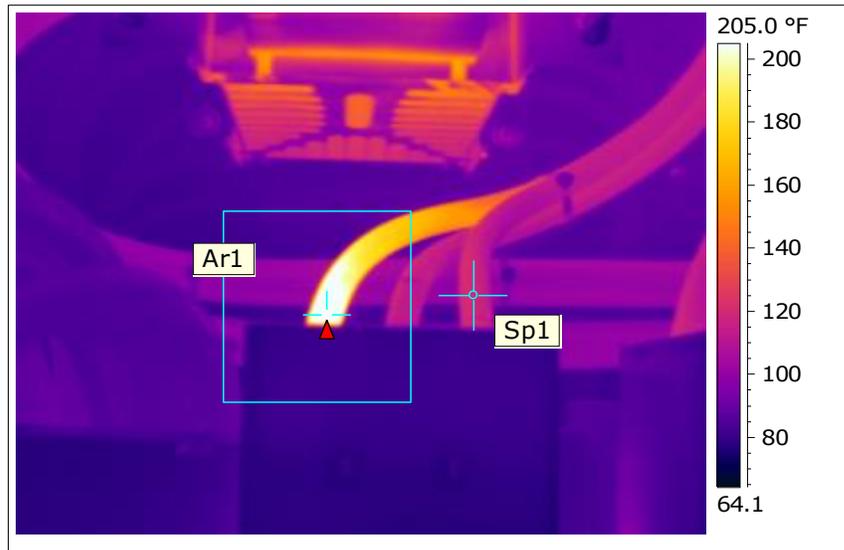
<b>REPORT #: 5</b>	
<b>CLIENT</b>	Pinnacle Widgets Inc
<b>BUILDING</b>	The Widget Building
<b>AREA 1</b>	Chip Core Bldg
<b>AREA 2</b>	Truck Loading
<b>EQPT NAME</b>	P49D FDISC
<b>Image Date</b>	4/14/2011
<b>Image Time</b>	8:22:51 AM
<b>Image File Name</b>	IR_5.jpg

<b>Reference Temperature</b>	
Sp1.Temperature 134.1 °F	
Ar1.Max Temperature 257.0 °F	
Temperature Rise: 123 °F	
<b>Fault Rating Critical</b>	
<b>AMPERAGES:</b>	
Phase A	Amp Phase A: NA
Phase B	Amp Phase B: NA
Phase C	Amp Phase C: NA

**Poor Connections** - The thermal image finding is often indicative of a loose or poor connection. We recommend checking connection integrity with repairs as may be necessary.
